Manhole Inspection Summary

Manhole # S31GG_019MH

Insp Date: **1/17/07 9:57 AM**

Location Address: **PARK AVE**

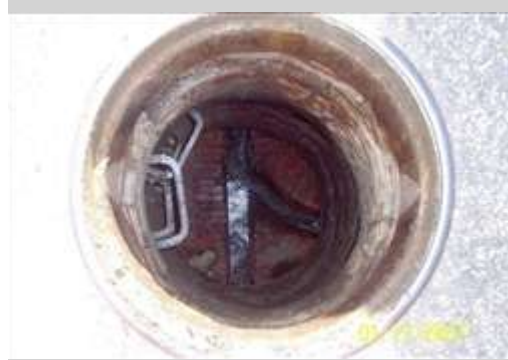
Top View

Frame leaks. Bench debris.

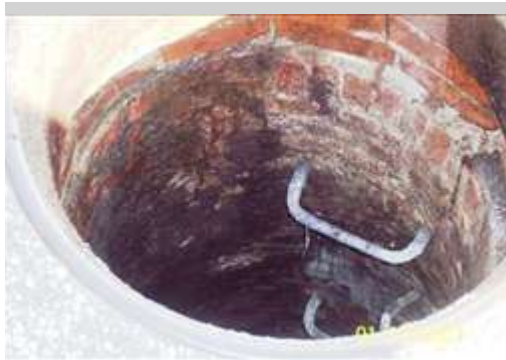
Defect

Adjustment and Corbel infiltration.

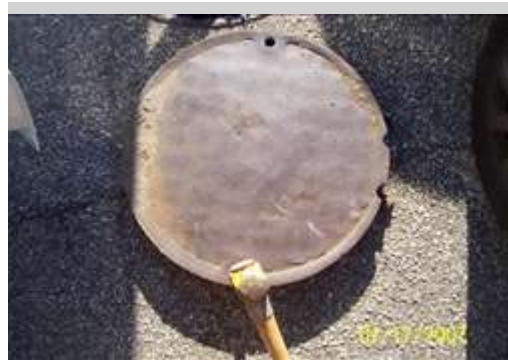
Defect

Worn cover.

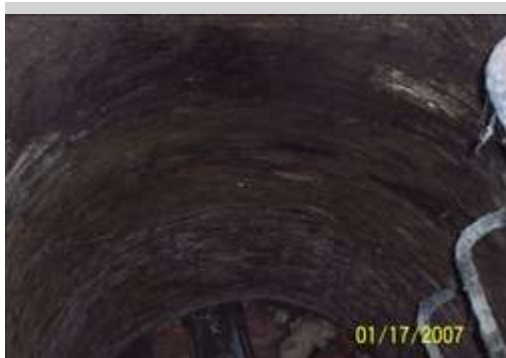
Defect

Corbel and Barrel infiltration.

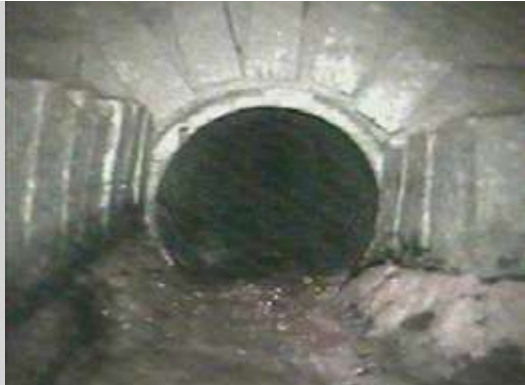
8 in. Circular Gravity Sewer Pipe Out @ 12 O'Clock

Infiltration: **Evidence** Pipe Seal Cond: **Unknown**

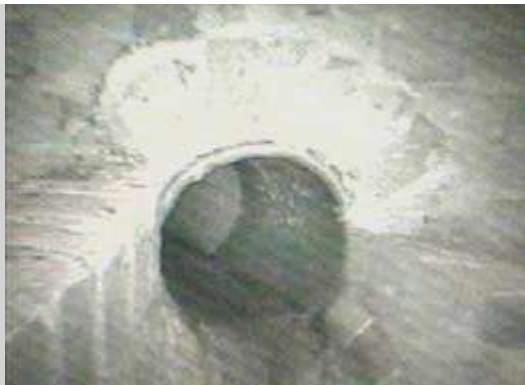
8 in. Circular Gravity Sewer Pipe In @ 3 O'Clock

Infiltration: **Evidence** Pipe Seal Cond: **Unknown**

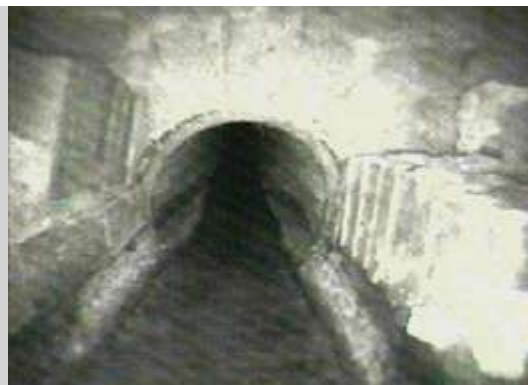
Pipe In @ 6 O'Clock

Deposits: ☐ None ☐ Mud ☐ Sludge ☐ Debris ☒ **Grease**

Deposits Extent: **Light**

Infiltration: **Evidence**
